**SELECTED MATERIAL FROM THE RESEARCH STUDY including the
CONDITION SURVEY OF THE EXISTING DRINKING WATER FOUNTAINS
IN SARAJEVO and CONCLUSIONS**

Jozic, Dino. Revitalisation of drinking fountains in the city of Sarajevo through the prism of climate change. Master Thesis. Sarajevo: International Burch University, 2023, pp.1-132

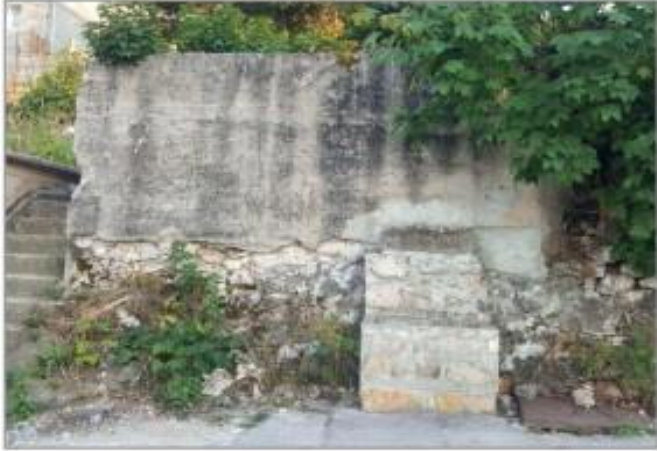
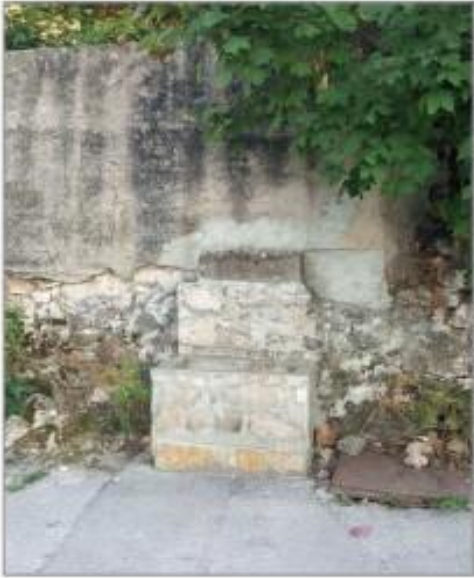
ID:1	NAZIV ČESME: "Begovac"		
FOTOGRAFIJA	Datum: 04.08.2022.

LOKACIJA:	Općina Stari Grad Ul. Paje 45		
N: E:	Materijal: <input checked="" type="checkbox"/> prirodni kamen <input checked="" type="checkbox"/> beton <input type="checkbox"/> imitacija kamena <input type="checkbox"/> drvo <input type="checkbox"/>	Korito: <input checked="" type="checkbox"/> da <input type="checkbox"/> ne <input type="checkbox"/>	Način korištenja: <input type="checkbox"/> stalno teče <input checked="" type="checkbox"/> slavina <input type="checkbox"/> senzor <input type="checkbox"/>
VIK oznaka brojila:	Stanje: <input type="checkbox"/> zapušteno <input checked="" type="checkbox"/> nedovoljno održavano <input type="checkbox"/> održavano <input type="checkbox"/>	Funkcionalnost: <input type="checkbox"/> u funkciji <input checked="" type="checkbox"/> van funkcije <input type="checkbox"/> djelomično u funkciji	Ambijent: <input type="checkbox"/> zid objekta <input type="checkbox"/> sjecište <input type="checkbox"/> skver <input checked="" type="checkbox"/> saobraćajnica <input type="checkbox"/> park <input type="checkbox"/>

Zabilješka:	Mještani tvrde da je nakon pucanja cijevi trajno zatvorena česma. Tako stoji više godina. Stanovnici su istakli da bi bilo korisno da se popravi. Nisu znali da li je nekome posvećena česma.		
Mjere:	Popravka vodovodne instalacije i puštanje vode.

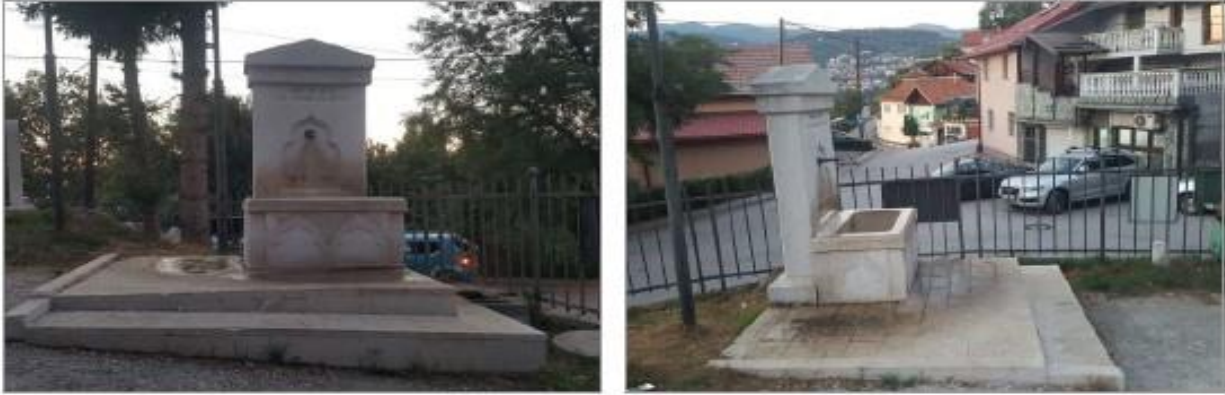
ID:3	NAZIV ČESME: "za groblje na Hridu"		
FOTOGRAFIJA	Datum: 04.08.2022.

LOKACIJA:	Općina Stari Grad Ul. Kamenica PP 1		
N: E:	Materijal: <input checked="" type="checkbox"/> prirodni kamen <input type="checkbox"/> beton <input type="checkbox"/> imitacija kamena <input type="checkbox"/> drvo <input type="checkbox"/>	Korito: <input checked="" type="checkbox"/> da <input type="checkbox"/> ne <input type="checkbox"/>	Način korištenja: <input checked="" type="checkbox"/> stalno teče <input type="checkbox"/> slavina <input type="checkbox"/> senzor <input type="checkbox"/>
VIK oznaka brojila:	Stanje: <input type="checkbox"/> zapušteno <input type="checkbox"/> nedovoljno održavano <input checked="" type="checkbox"/> održavano <input type="checkbox"/>	Funkcionalnost: <input checked="" type="checkbox"/> u funkciji <input type="checkbox"/> van funkcije <input type="checkbox"/> djelomično u funkciji	Ambijent: <input type="checkbox"/> zid objekta <input type="checkbox"/> sjecište <input type="checkbox"/> skver <input type="checkbox"/> saobraćajnica <input type="checkbox"/> park <input checked="" type="checkbox"/> mezarje

Zabilješka:	Česma se nalazi u okviru mezarja na Hridu, i prema natpisu na česmi nastala je u povodu 118 godina postojanja preduzeća Vodovod i kanalizacija.		
Mjere:	Redovno održavanje i čišćenje.

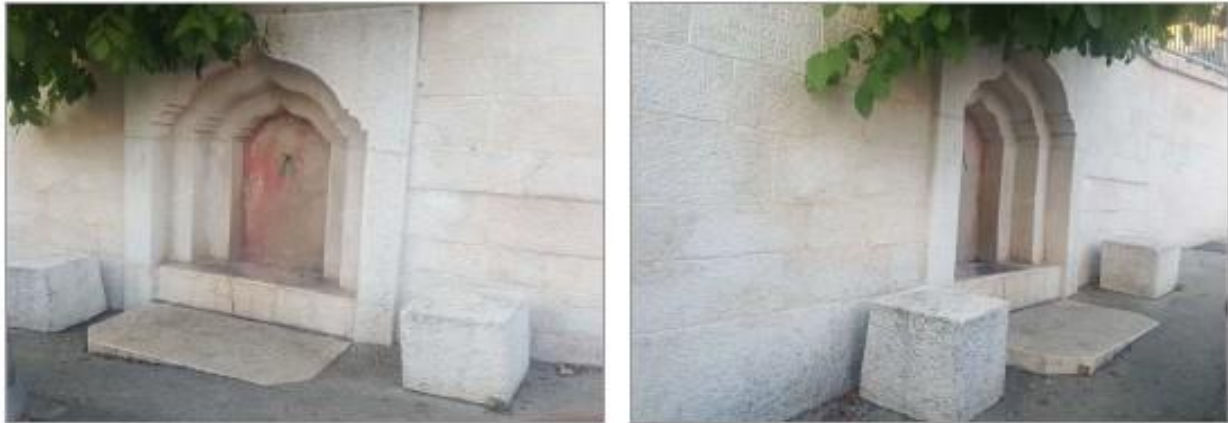
ID:7	NAZIV ČESME: "Gornja Breka"		
FOTOGRAFIJA	Datum: 05.08.2022.

LOKACIJA:	Općina Centar Ul. Gornja Breka PP 9		
N: E:	Materijal: <input checked="" type="checkbox"/> prirodni kamen (mermer) <input type="checkbox"/> beton <input type="checkbox"/> imitacija kamena <input type="checkbox"/> drvo	Korito: <input checked="" type="checkbox"/> da <input type="checkbox"/> ne <input type="checkbox"/>	Način korištenja: <input type="checkbox"/> stalno teče <input checked="" type="checkbox"/> slavina <input type="checkbox"/> senzor <input type="checkbox"/>
VIK oznaka brojila:	Stanje: <input type="checkbox"/> zapušteno <input type="checkbox"/> nedovoljno održavano <input checked="" type="checkbox"/> održavano <input type="checkbox"/>	Funkcionalnost: <input checked="" type="checkbox"/> u funkciji <input type="checkbox"/> van funkcije <input type="checkbox"/> djelomično u funkciji	Ambijent: <input type="checkbox"/> zid objekta <input type="checkbox"/> sjecište <input type="checkbox"/> skver <input checked="" type="checkbox"/> saobraćajnica <input type="checkbox"/> park

Zabilješka:	Hair česma braniocima Bosne i Hercegovine. Nalazi se pored saobraćajnice uklopljena u podzid. Tesko saglediva i dostupna zbog parkiranih automobila. Vrlo kvalitetno urađena i uklopljena u ambijent. Primjećena zaprljanost crvenom bojom (farbom).		
Mjere:	Uklanjanje crvene farbe sa česme, a potom redovno čišćenje i održavanje. Zabraniti parkiranje ispred česme.

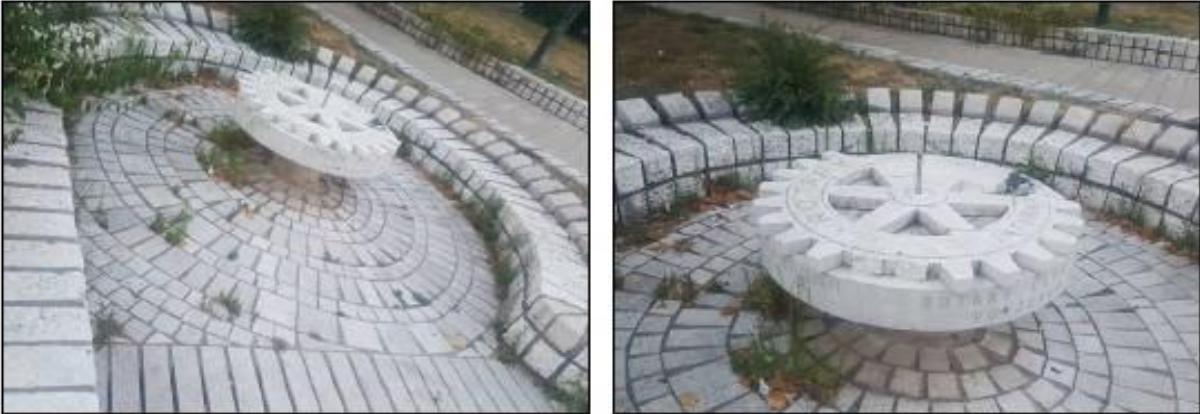
ID:17	NAZIV ČESME: "Fontana Rotary"		
FOTOGRAFIJA	Datum: 07.08. 2022.

LOKACIJA:	Općina Centar Ul.Reisa Džemaludina Čauševića 1		
N: E:	Materijal: <input checked="" type="checkbox"/> prirodni kamen <input type="checkbox"/> beton <input type="checkbox"/> imitacija kamena <input type="checkbox"/> drvo	Korito: <input type="checkbox"/> da <input checked="" type="checkbox"/> ne <input type="checkbox"/>	Način korištenja: <input type="checkbox"/> stalno teče <input type="checkbox"/> slavina <input type="checkbox"/> senzor <input checked="" type="checkbox"/> vodoskok
VIK oznaka brojila:	Stanje: <input checked="" type="checkbox"/> zapušteno <input type="checkbox"/> nedovoljno održavano <input type="checkbox"/> održavano <input type="checkbox"/>	Funkcionalnost: <input type="checkbox"/> u funkciji <input checked="" type="checkbox"/> van funkcije <input type="checkbox"/> djelomično u funkciji	Ambijent: <input type="checkbox"/> zid objekta <input type="checkbox"/> sjecište <input checked="" type="checkbox"/> skver <input type="checkbox"/> saobraćajnica <input type="checkbox"/> park <input type="checkbox"/> mezarje

Zabilješka:	Fontana se nalazi u "parku Đuro Đaković", napravljena kao donacija Rotary kluba voljenom gradu, u saradnji sa još nekoliko firmi čija se imena nalaze ispisana na fontani.Relativno dobro uklopljena u ambijent. Fontana oštećena i nije u funkciji.		
Mjere:	Neophodan popravak fontane i stavljanje u funkciju.

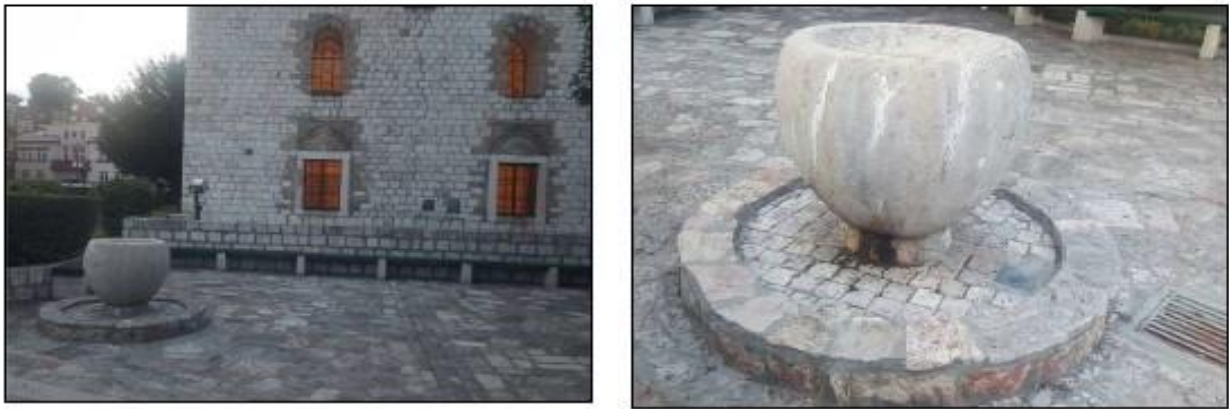
ID:19	NAZIV ČESME: "U parku iza Alipašine džamije"		
FOTOGRAFIJA	Datum: 07.08. 2022.

LOKACIJA:	Općina Centar Ul. Alipašina		
N: E:	Materijal: <input checked="" type="checkbox"/> prirodni kamen <input type="checkbox"/> beton <input type="checkbox"/> imitacija kamena <input type="checkbox"/> drvo	Korito: <input type="checkbox"/> da <input checked="" type="checkbox"/> ne <input type="checkbox"/>	Način korištenja: <input type="checkbox"/> stalno teče <input type="checkbox"/> slavina <input type="checkbox"/> senzor <input checked="" type="checkbox"/> vodoskok
VIK oznaka brojila:	Stanje: <input type="checkbox"/> zapušteno <input checked="" type="checkbox"/> nedovoljno održavano <input type="checkbox"/> održavano <input type="checkbox"/>	Funkcionalnost: <input type="checkbox"/> u funkciji <input checked="" type="checkbox"/> van funkcije <input type="checkbox"/> djelomično u funkciji	Ambijent: <input type="checkbox"/> zid objekta <input type="checkbox"/> sjecište <input checked="" type="checkbox"/> skver <input type="checkbox"/> saobraćajnica <input type="checkbox"/> park <input type="checkbox"/> mezarje

Zabilješka:	Česma se nalazi u parku iza Alipašine džamije, vrlo skladno uklopljena u ambijent. Nije u funkciji.		
Mjere:	Neophodan popravak fontane i stavljanje u funkciju.

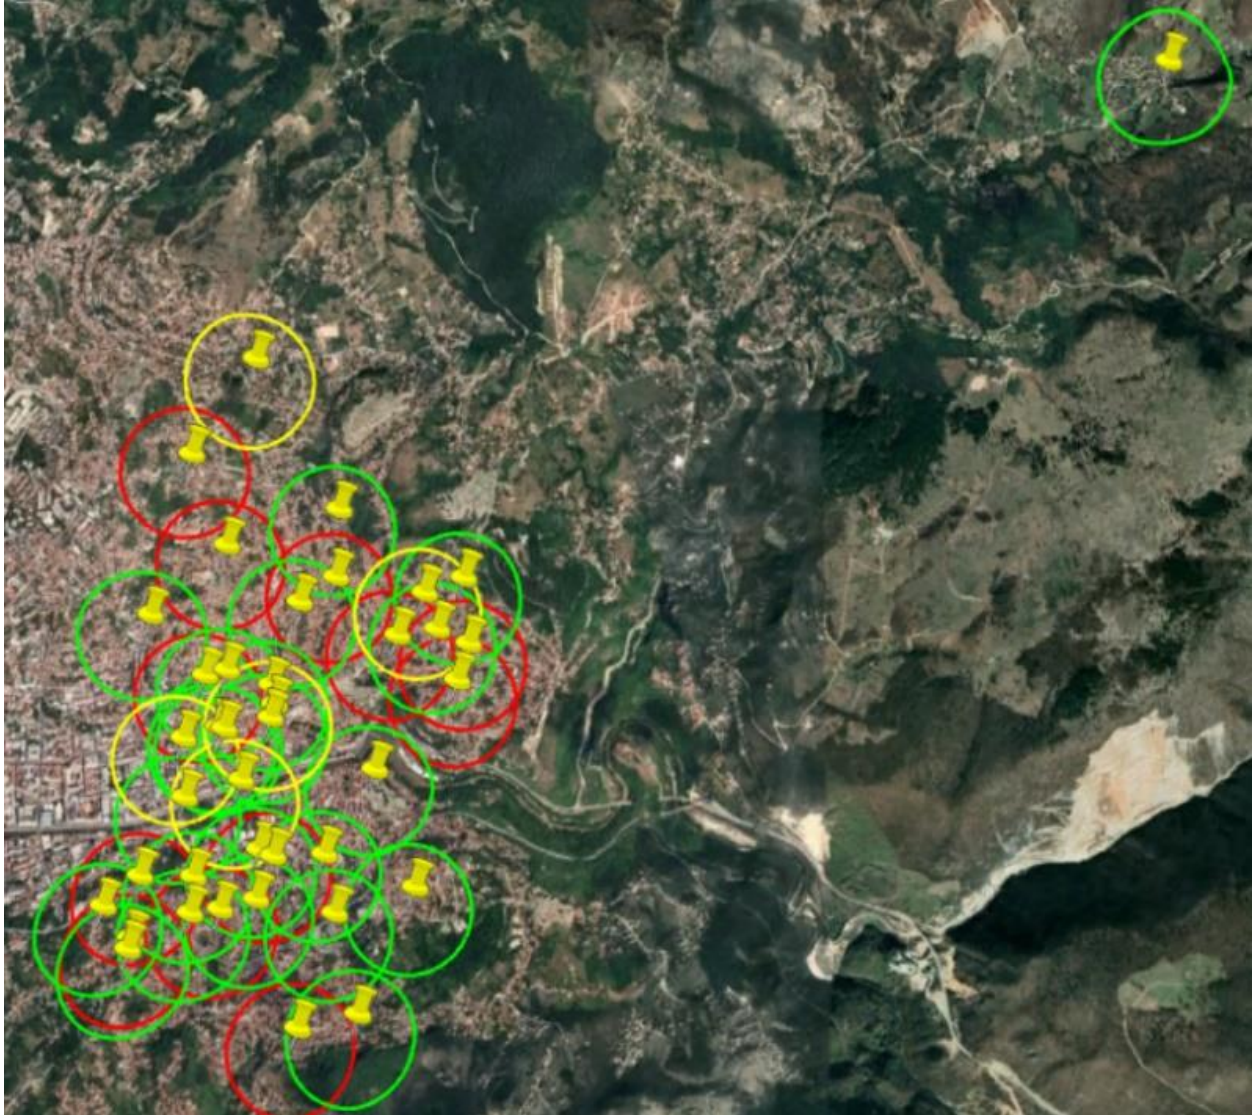
Figure 55: Impacts of drinking fountains in Municipality of Stari Grad
p.101

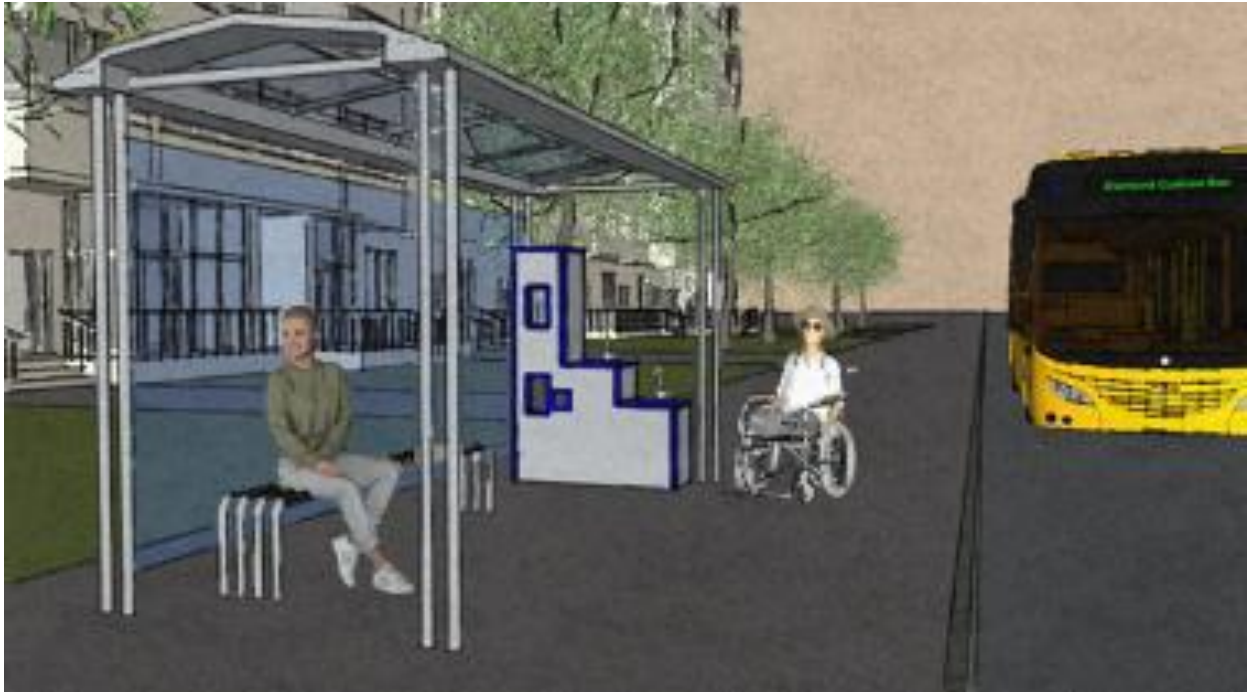
Figure 61: Perspective view of the public transport drinking fountain module
p.119
